**GOODYEAR AIRCRAFT CORPORATION**  
AKRON, OHIO

Final Engineering Report on  
Modifications and Testing of  
A One-Place Inflatoplane  
GA-468

GER 10416

September 1961

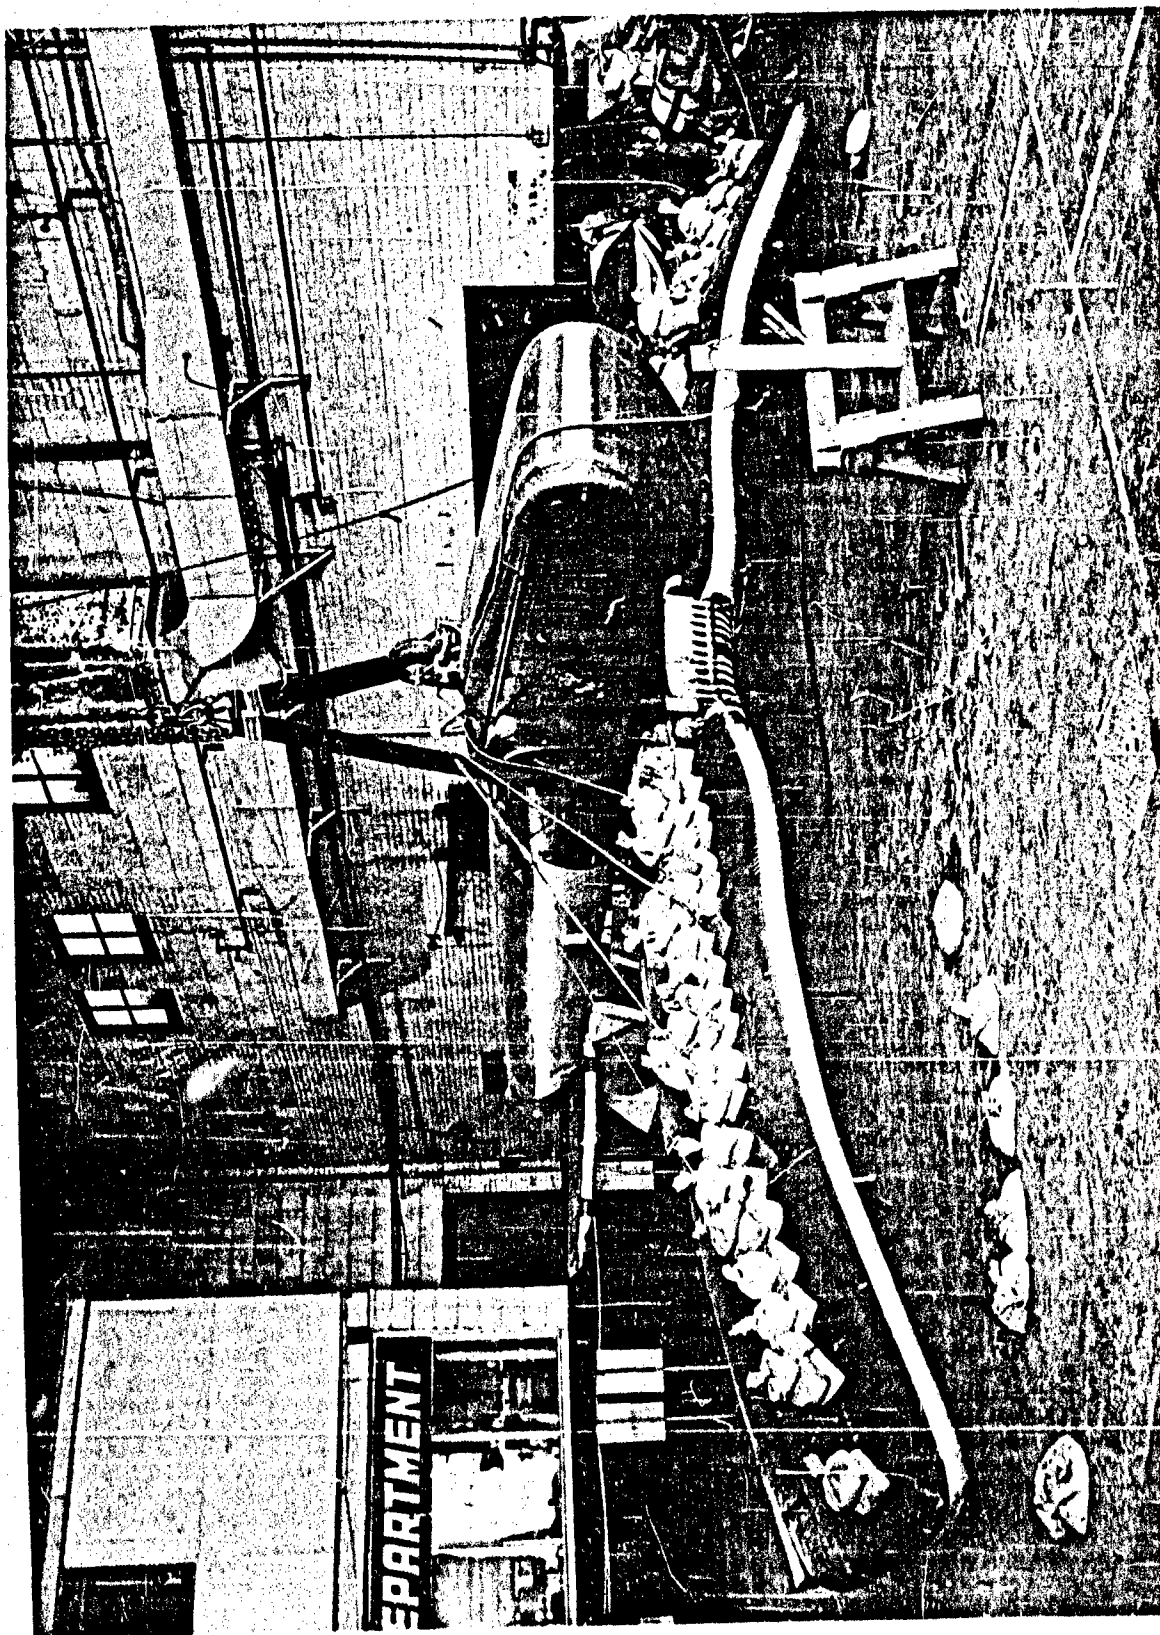
FIGURE 8 - GA 468 WING UNDER +5.0 g LOAD

Several wing-guy-cable arrangements were tried before it was found necessary to add an aluminum plate between the landing gear and the fuselage to limit the fuselage deflection caused by the method of supporting the Inflatoplane, which is different than in flight. This lowering of the deflection reduced the aeroelastic effect on the aerodynamic characteristics and allowed tunnel load factors up to 4.76, flight load factor of 5.13, before wing buckling occurred.

During run 21h both the left and right wings buckled and the right wing cable, 2B, failed precipitating a separation of wing from the bulkhead straps and a rip in the wing. This failure, which was caused by a frayed cable, ended the tests."
